Subject: McGuire Nuclear Station, Unit 1 and 2
Docket No. 50-369
Licensee Event Report 369/97-09, Revision 0
Problem Investigation Process No.: 0-M97-3255

McGuire Nuclear Station, Unit 1

Reactor Trip On Both Units Due To An Equipment Failure And Operation Prohibited by Technical Specifications Due To Failure To Comply With Required Action Statements

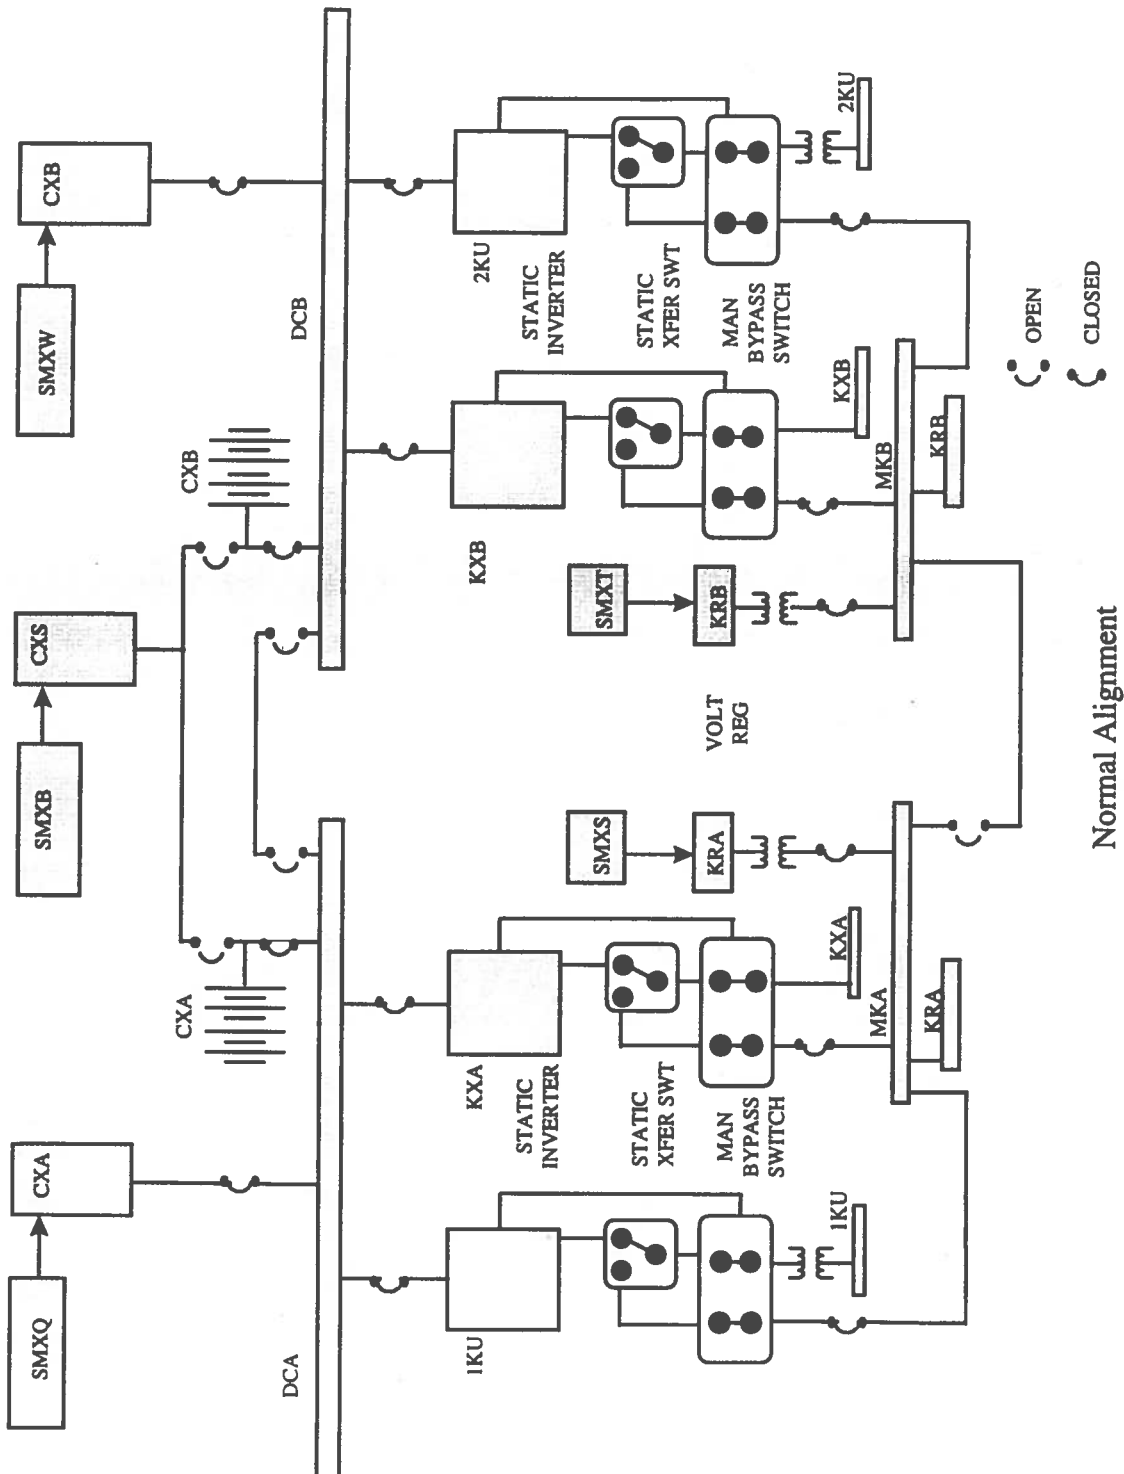
The 125 VDC Auxiliary Control Power System (EPK) [EIIS:EI] (See Normal Alignment, page 14 of 15) provides non-safety DC control power to Unit 1 and Unit 2 equipment in the Auxiliary and Turbine Buildings and also supplies power to the Operator Aid Computer (OAC) and Auxiliary Control Power Inverters [EIIS:INVT]. The system serves as an uninterruptible power supply for non-safety related loads requiring DC power through the Battery chargers [EIIS:BYC] and batteries [EIIS:BT] or AC power through the Auxiliary Control Inverters.

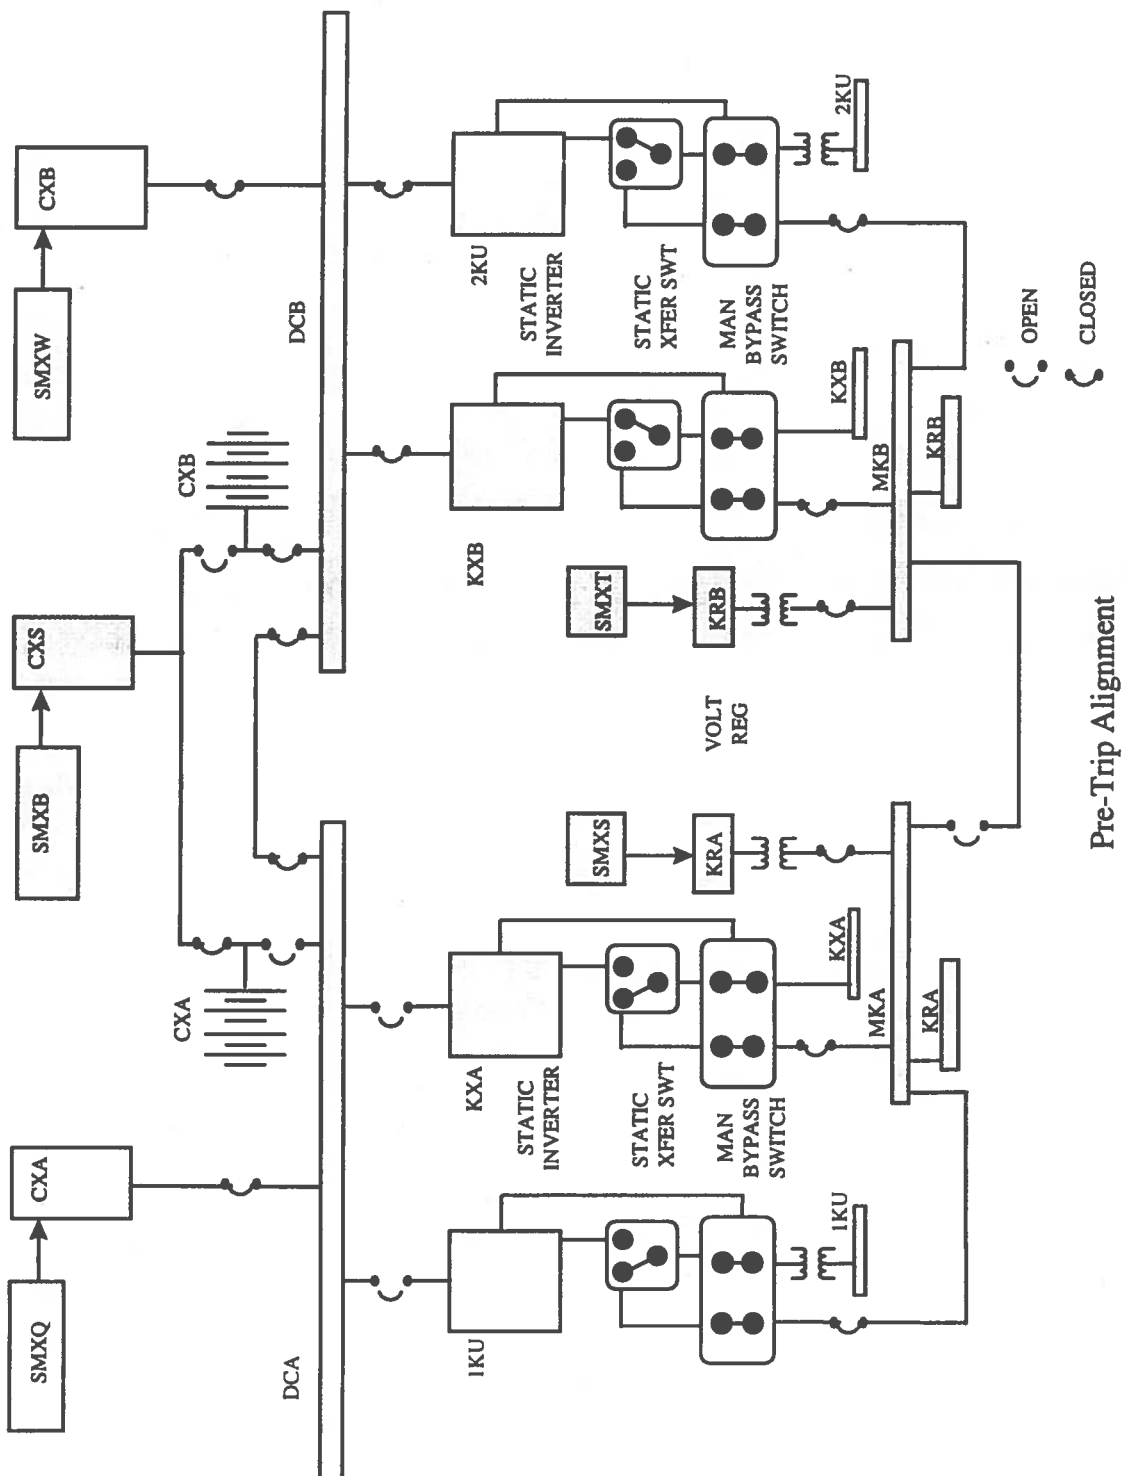
On September 6, 1997, prior to the event, Units 1 and 2 were in Mode 1 (Power Operation) at 100 percent power. EPK System Battery CXA had been isolated from the DCA Bus [EIIS:BU] for equalize charge following annual service testing and maintenance. Bus DCA had been cross tied to Bus DCB and, as a result, inverters 1KU and KXA were shut down with the associated Power Panel Boards (1KU and KXA) being supplied power from the regulated alternate AC source through Regulated Power Distribution Center MKA (See Pre-Trip Alignment, page 15 of 15).

At 2146:31.33, Breaker MKA-1B, Inverter KXA Manual Bypass Switch Alternate Supply, tripped. This de-energized Power Panel Board KXA.

The breaker trip has been determined to be an equipment failure due to heat build-up created by a loose cable connection on the load side of the breaker. This heat build-up actuated the breaker thermal trip units. The cause of the loose connection has been determined to be a construction/installation deficiency. This is based on expectation that the connection should have been torqued per manufacturer's recommended values during initial installation. Although no preventive maintenance checks to verify torque had been performed, the corresponding connection on the same breaker, which would have been subjected to the same environment and stresses, was found to be tight. Also, all remaining connections on Non-vital Buses MKA and MKB were checked for correct torque and found to be tight. Therefore, it has been determined that the correct torque was not applied to this connection during initial installation.

1. Breaker MKA-1B was re-closed and KXA was restored to service.
2. Breaker MKA-1B was replaced and the cable connection repaired.
3. Enclosures 4.9, 4.10, and 4.11, which provide guidance in Operations procedure OP/0/A/6350/01B for placing Batteries CXA and CXB on or removing from equalization charge, were deleted to prevent placing the 125 VDC Auxiliary Control Power System in a similar alignment until evaluation of the event could be completed.
4. Associated cable connections on Non-vital Buses MKA and MKB were checked for correct torque.
